# Crychan Forestry, Carmarthenshire

ARCHAEOLOGICAL SURVEY

CPAT Report No 873

**N W Jones and W J Owen**  
May 2007

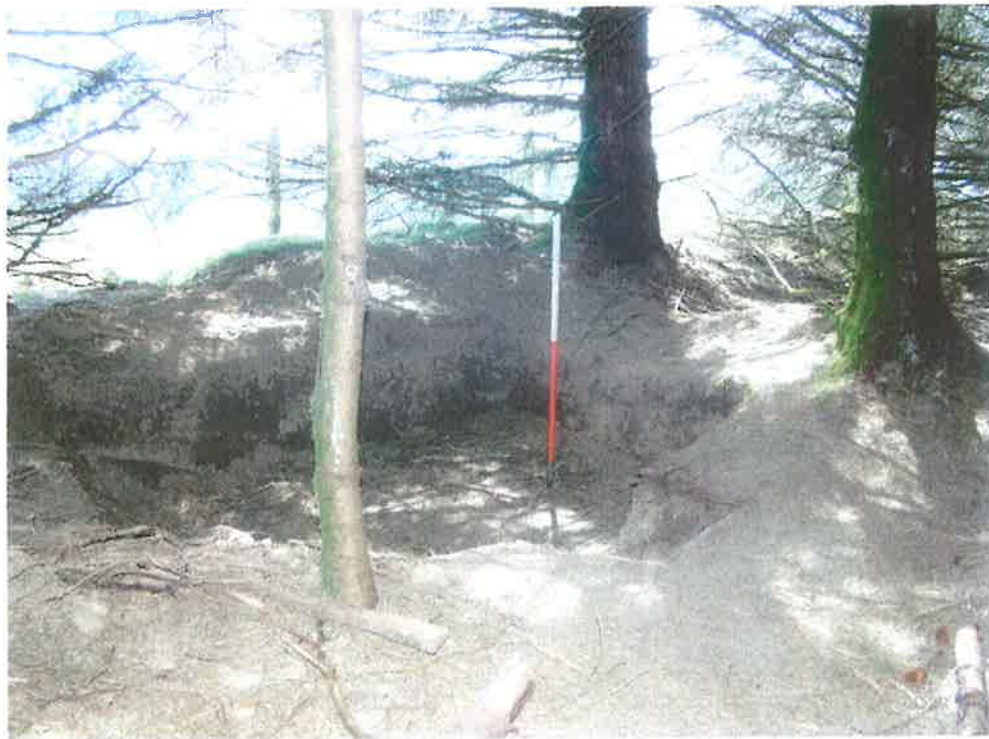
The forested half of the enclosure is covered with mature conifers. In places there is serious damage to the banks and internal ground surface resulting from military activity. Motorbikes have formed eroded tracks across the area and cutting through the banks.

PRN 273 Crychan Forest Fortlet – damage resulting from military dugout. Photo CPAT  
2354.004

Carefully remove conifers. Monitor and preserve in-situ. Exclude the site and wider area from replanting. Ensure that army activities as well as motor bikes and bike events are excluded from the area. Reinstate the damage caused by military activities.

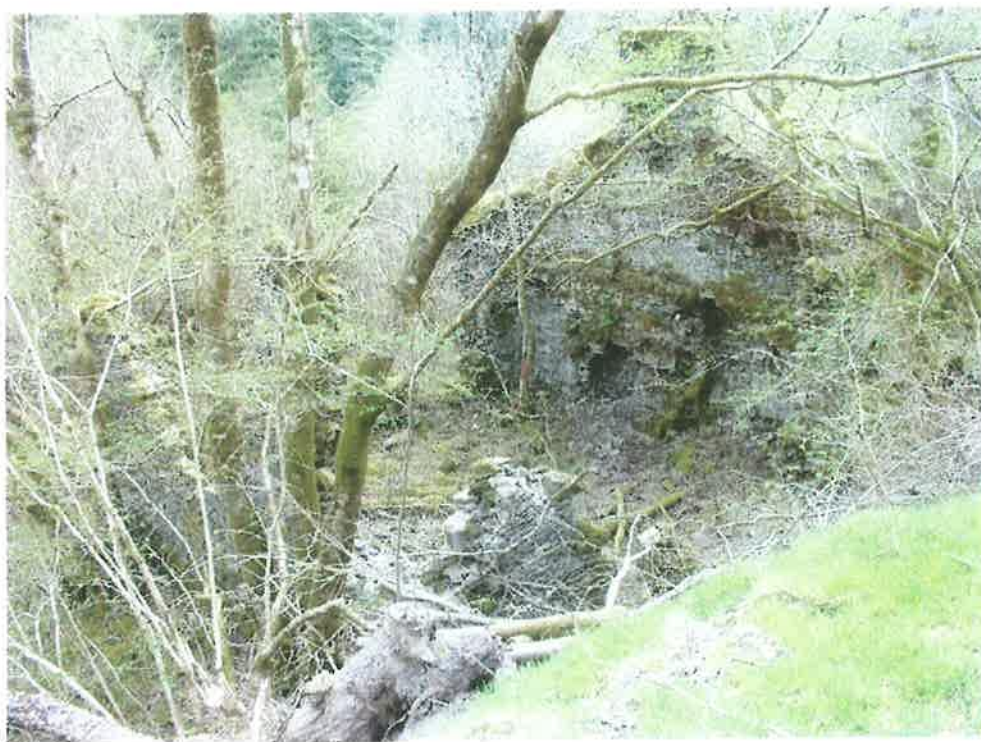
PRN 44668 Scrâch Farmhouse from N. Photo CPAT 2354.022

The whole structure appears fragile, and the gable end walls in particular are in a very unstable and perilous condition. The house is surrounded by the saplings of broadleaf trees, some of which are growing within the structure.

Clear saplings. Monitor and preserve in situ. Avoid during forestry operations and exclude site and wider area from future planting.

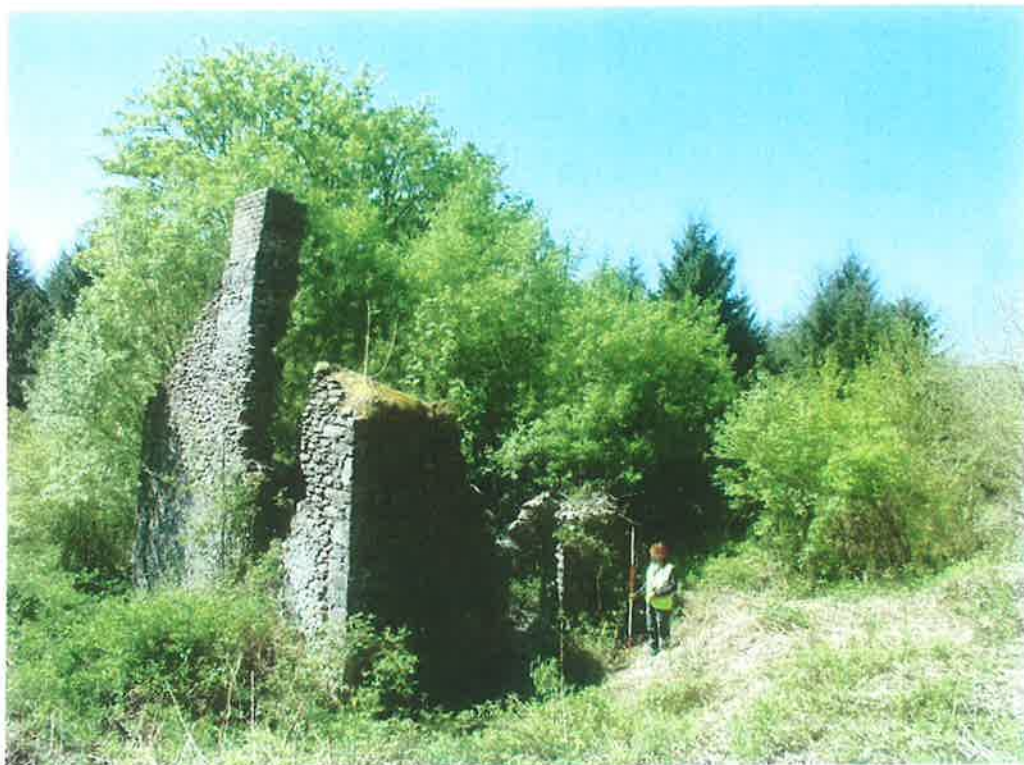
PRN 44673 Glyn-môch Farmhouse from E. Photo CPAT 2354.039

Broadleaf saplings within and around the building. The masonry is loose and unstable.

Clear saplings. Monitor and preserve in situ. Avoid during forestry operations and exclude site and wider area from replanting.

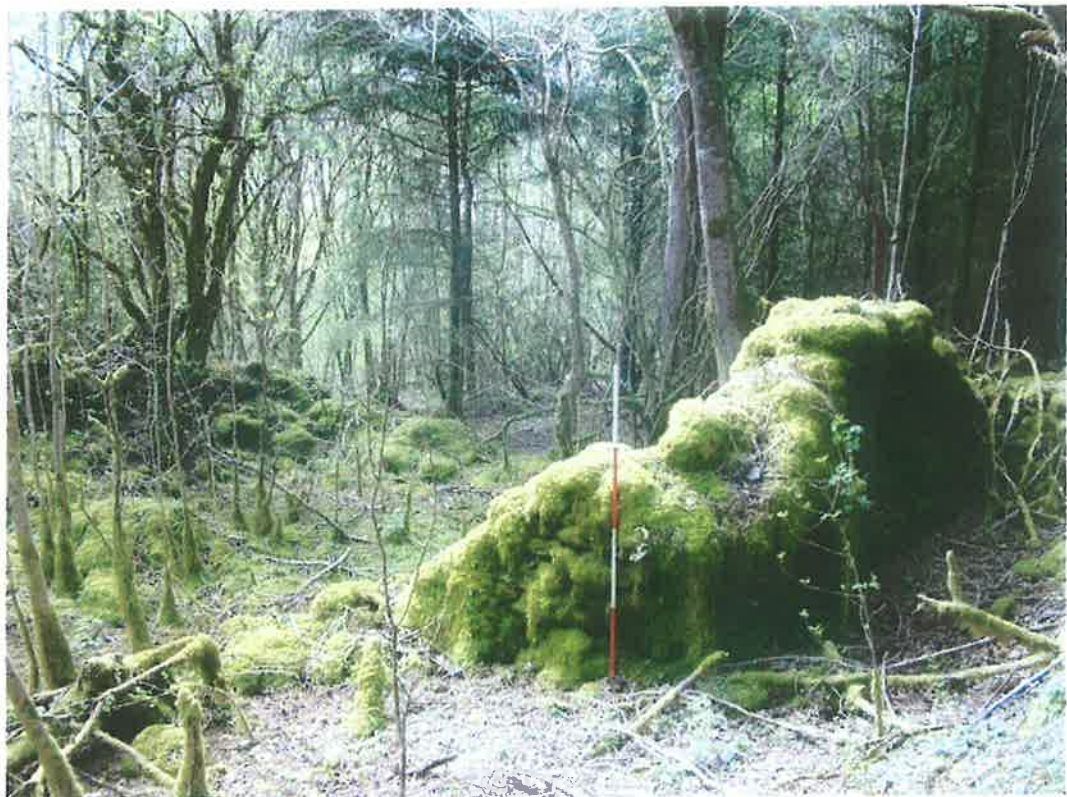
PRN 62776 Cefn-gareg Farmhouse from NW. Photo CPAT 2354.009

The area has been left as a riparian zone between conifers and there has been a natural seeding of broadleaves. The building is in reasonably good condition.

Clear saplings. Monitor and preserve in situ. Fence during felling operations and exclude site and wider area from replanting.

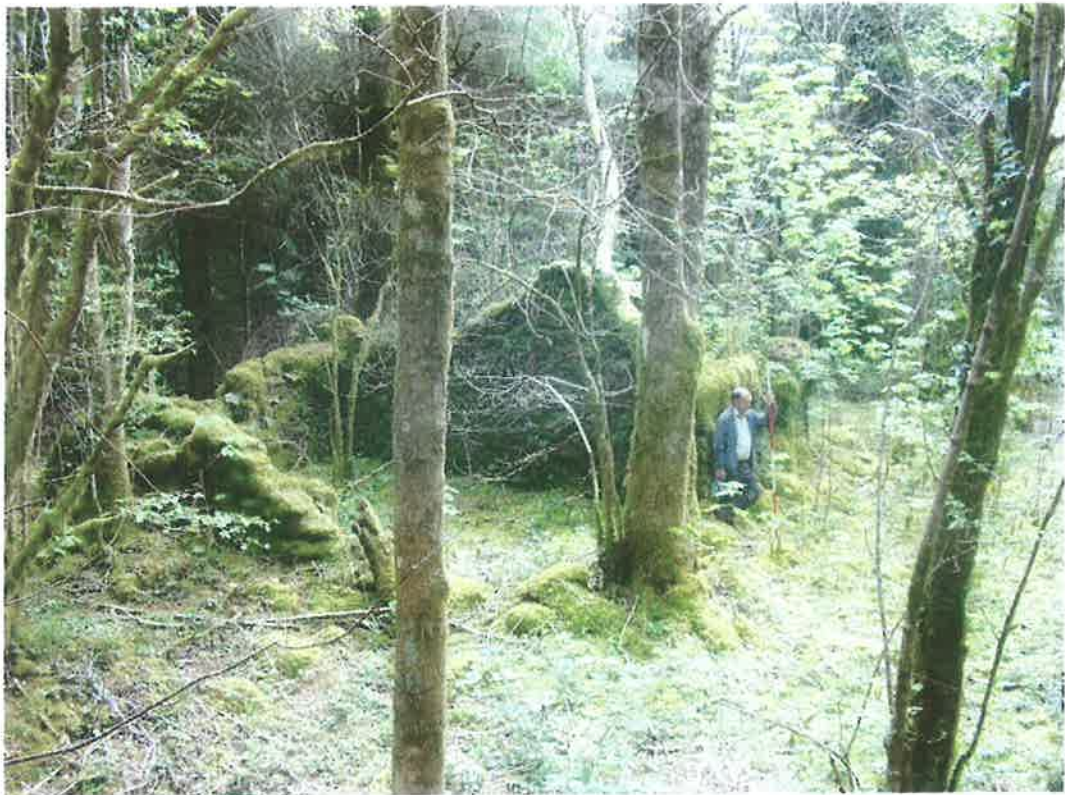
PRN 62777 Cefn-gareg Barn from N. Photo CPAT 2354.009

The area has been left as a riparian zone between conifers and there has been a natural seeding of broadleaves. The building is in reasonably good condition.

Clear saplings. Monitor and preserve in situ. Fence during felling operations and exclude site and wider area from replanting.

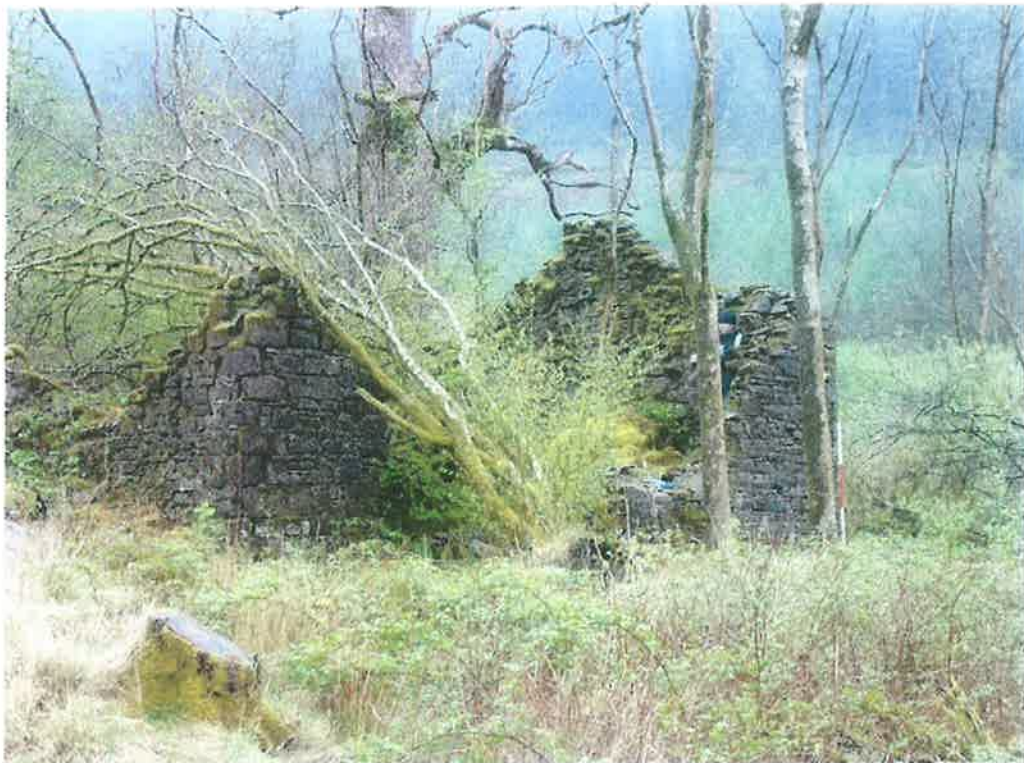
PRN 62778 Cwrte-bach Farmhouse from NW. Photo CPAT 2354.014

The building is in poor condition, and the mortar is now loose. There are small trees and saplings within and around the buildings.

Clear saplings. Monitor and preserve in situ. Fence during felling operations and exclude site and wider area from replanting.

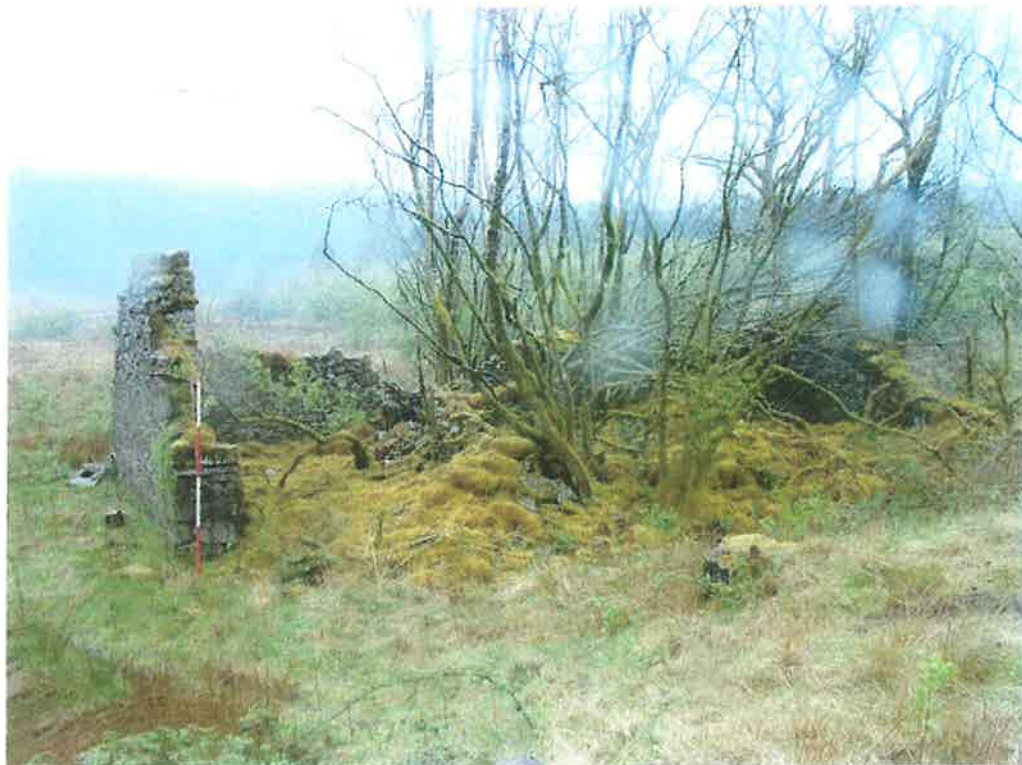
PRN 62779 Cwrte-bach Barn from ESE. Photo CPAT 2354.013

The building is in poor condition, and the mortar is now loose. There are small trees and saplings within and around the buildings.

Clear trees and saplings. Monitor and preserve in situ. Fence during felling operations and exclude site and wider area from replanting.

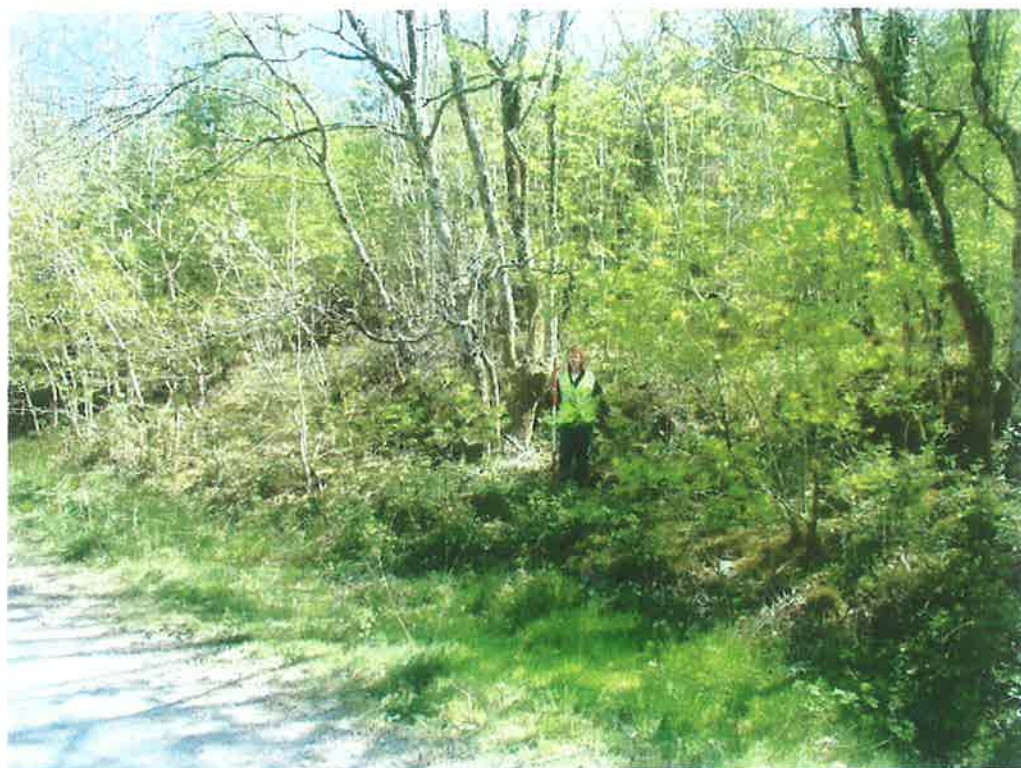
PRN 62786 Pen-lan Farmhouse from WSW. Photo CPAT 2354.037

Part of Pen-lan Farmstead (PRN 30223). There is now no obvious surviving walling of the farmhouse, although there is a large platform terraced into the slope on the eastern edge of the forest road which has a considerable quantity of rubble and possible walling. It is likely that the foundations and floors survive beneath the rubble.

Clear saplings and undergrowth. Monitor and preserve in situ. Fence during felling operations and exclude site and wider area from replanting.

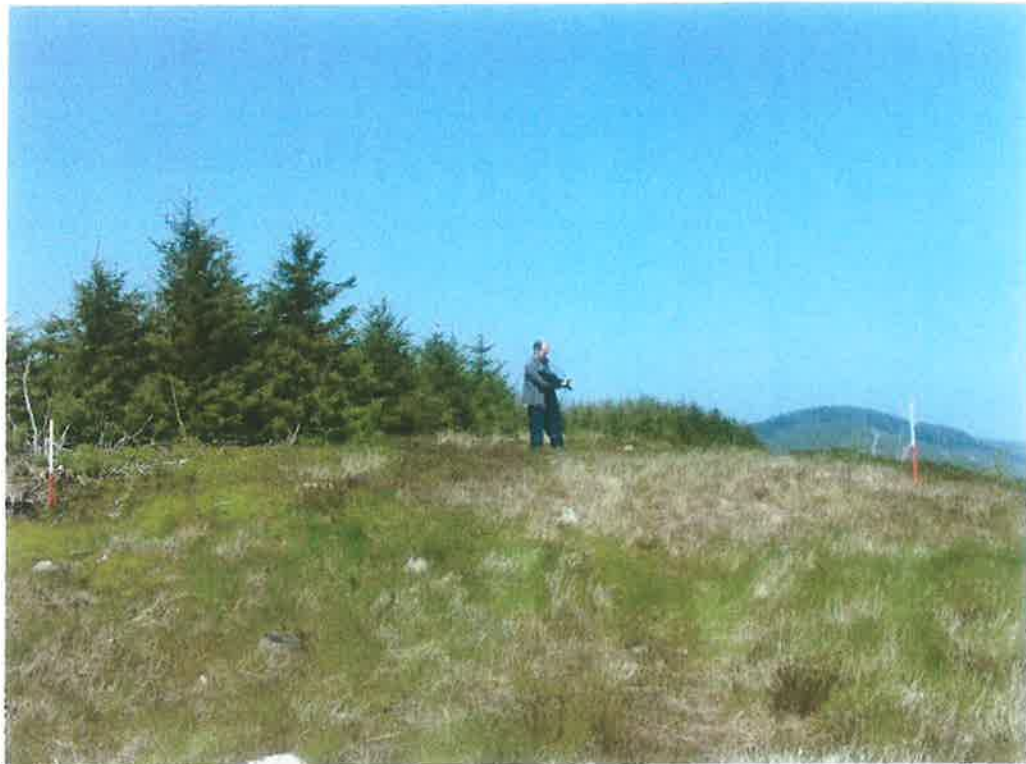
PRN 62788 Castell Craig-y-derwyddon cairn from SW. Photo CPAT 2354.057

The immediate area has been cleared of its conifer crop and left unplanted, though there is some regeneration of deciduous trees. The edge of the nearest planted conifer compartment lies c. 10m to the north. Some previous damage to the site has occurred during planting or clearance operations. An access route along the crest of the ridge crosses the site.

Monitor and preserve in situ. Fence during felling operations and exclude site and wider area from replanting. Exclude the passage of vehicles across the site and divert track

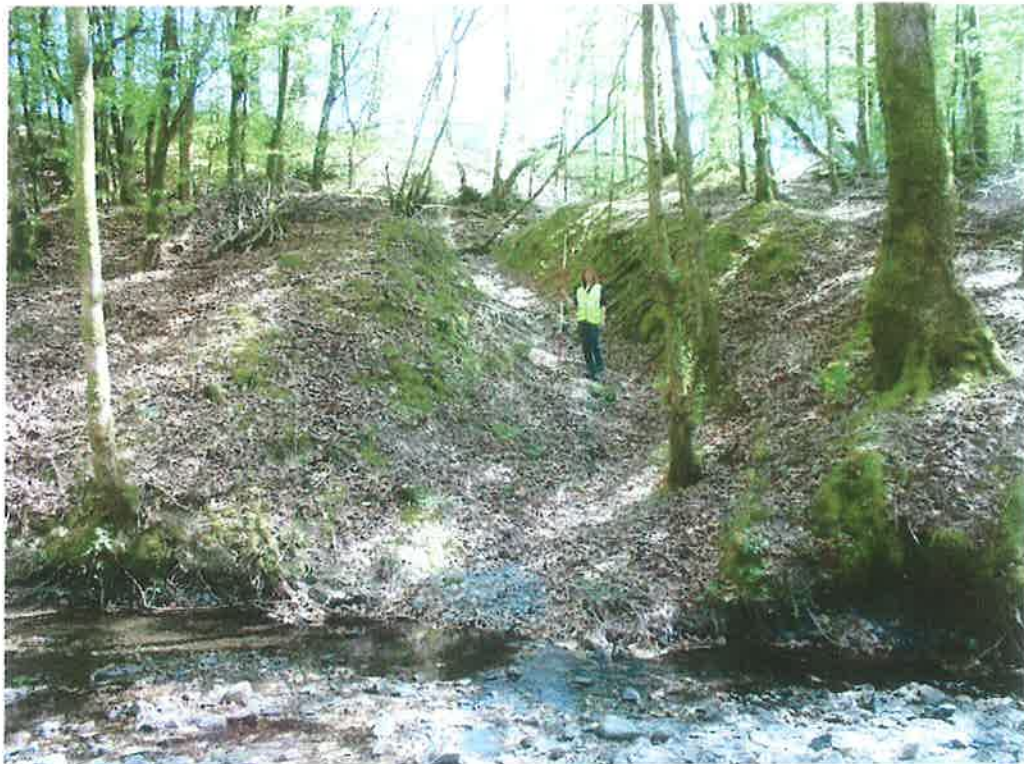
PRN 62793 Ty'n Wern holloway from NW. Photo CPAT 2354.044

A footbridge and ford are depicted on the Ordnance Survey 1<sup>st</sup> edition map. The field survey found no structural remains of the ford and footbridge, although on the south side of the stream there is a deeply cut holloway ascending the slope.

Monitor and avoid when felling/replanting.

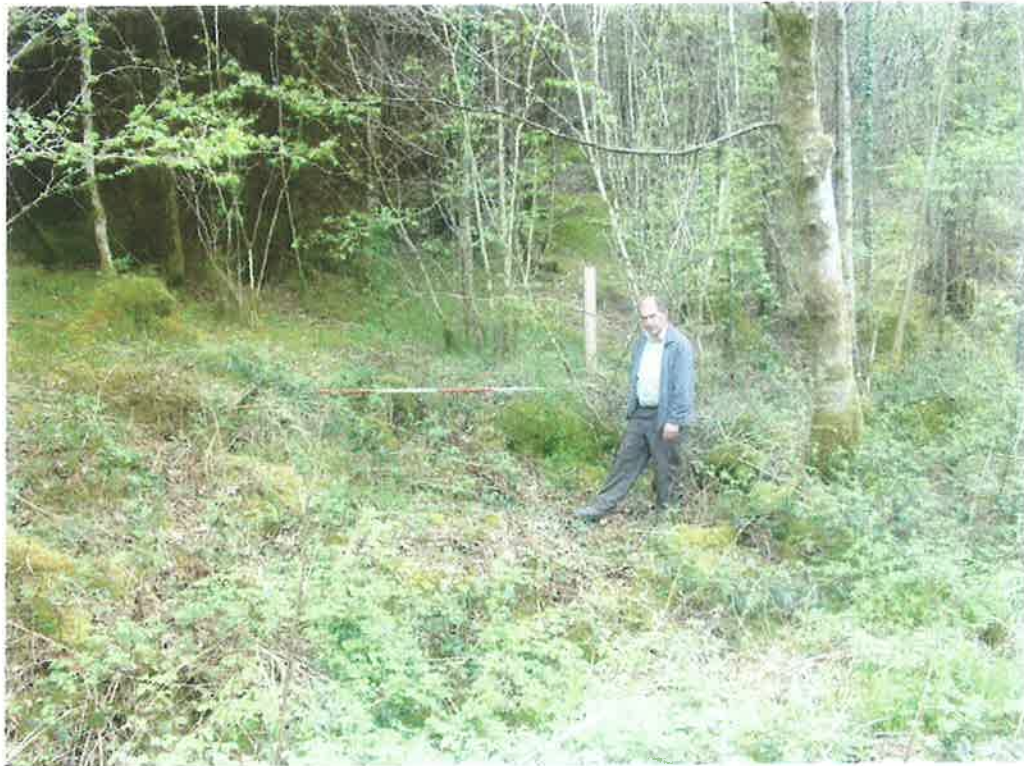
PRN 62804 Cwm Clwydfach Building from NNW. Photo CPAT 2354.012

The site has been heavily damaged by construction of the adjacent forest road. The site lies on the edge of the forest and is not actually forested, although there are saplings.

Clear saplings and undergrowth. Monitor and preserve in situ. Fence during felling operations and exclude site and wider area from replanting.
